Design & Access Statement

SITE ADDRESS
Craigrownie Church Hall,
Kilcreggan,
G84 0HW

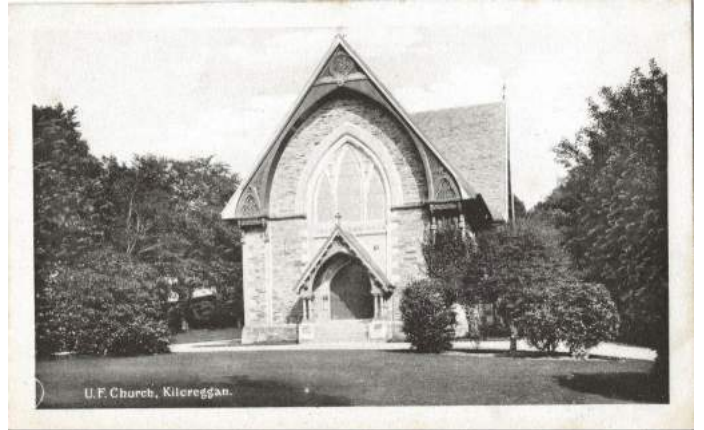
Historic photograph of the front face of the Church Hall. The timber fascia has since been removed.

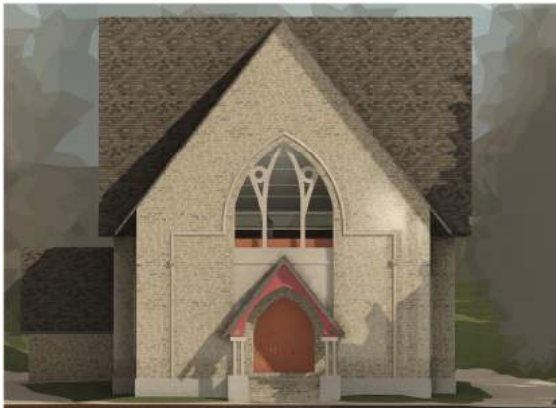
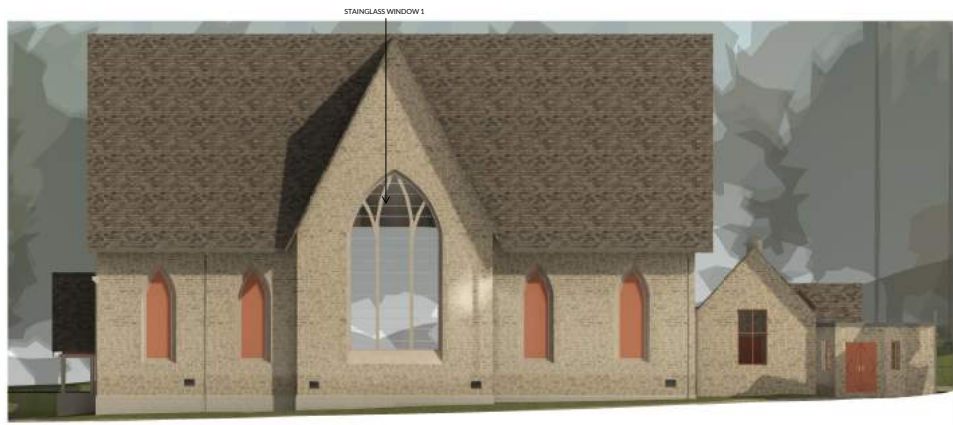
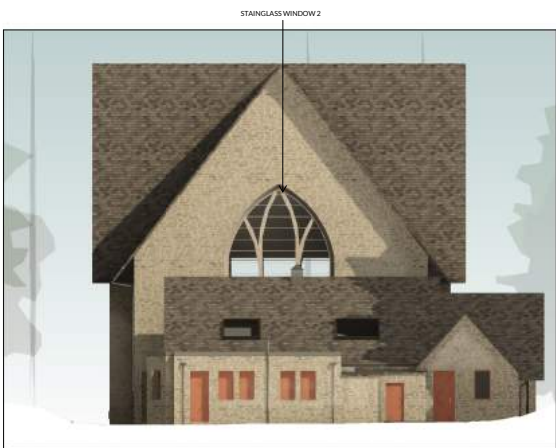
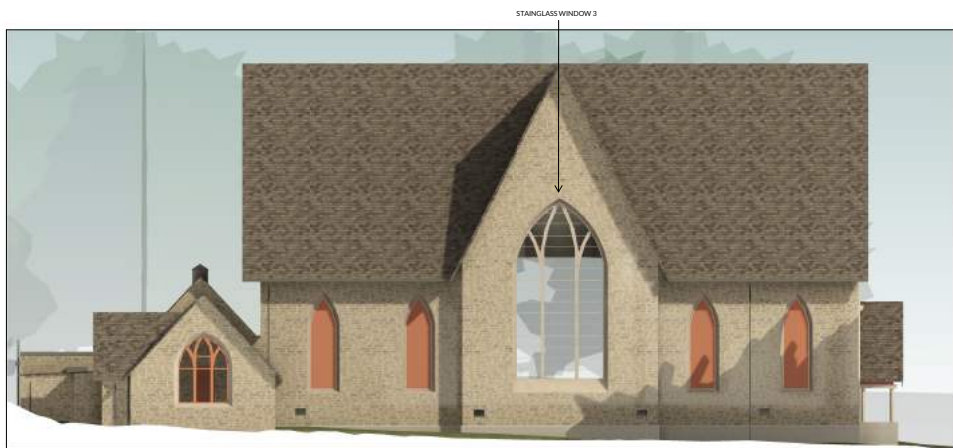
① WEST ELEVATION - AS EXISTING
1:100

② SOUTH ELEVATION - AS EXISTING
1:100

③ EAST ELEVATION - AS EXISTING
1:100

④ NORTH ELEVATION - AS EXISTING
1:100

Following a visual inspection, the building is mostly still in good condition. The front porch has strong signs of deterioration. The main roof has various leaks but the timber structure looks to be in good health. The annex roofs to the rear of the property are in various states with some requiring repair and others replacing. Many of the windows are currently boarded up due to vandalism. Please refer to the Building Condition Report included in this submission for a comprehensive analysis of the current condition of the Church Hall.

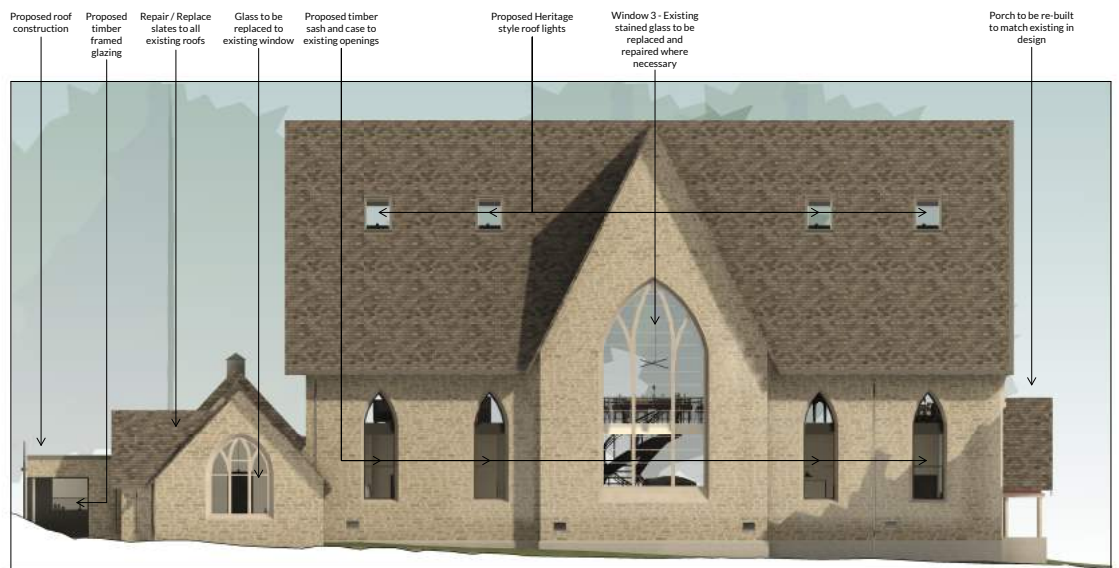
1 WEST ELEVATION - AS PROPOSED
1:100

2 SOUTH ELEVATION - AS PROPOSED
1:100

3 EAST ELEVATION - AS PROPOSED
1:100

4 NORTH ELEVATION - AS PROPOSED
1:100

As part of the renovation works, the client would like to restore the timber fascia to the front facing elevation in order to bring back the original character of the Church Hall. The proposed rooflights will be an appropriate size, to either side of the property rather than front facing, and flush with the roof to remain in-keeping within the conservation area.

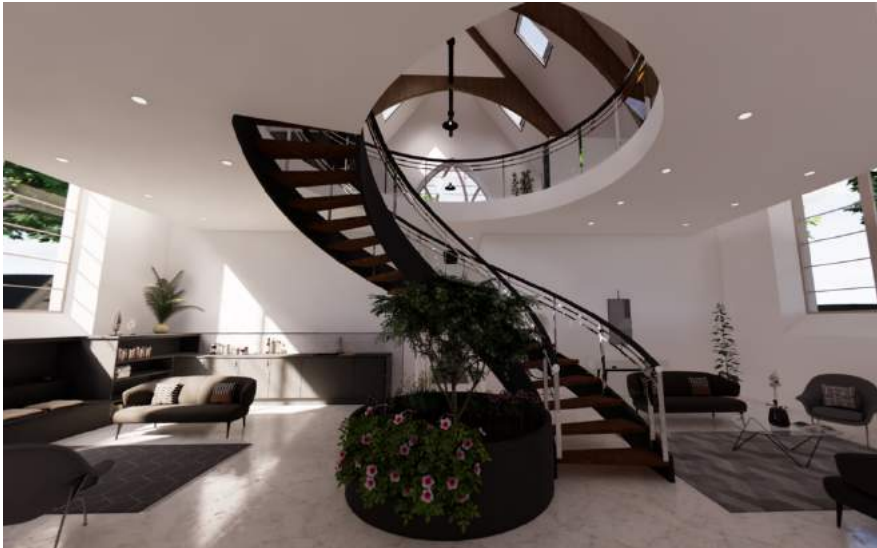
Spiral stair

Both floor levels are connected via a single spiral staircase, located in the heart of the plan. This location of the stair takes the biggest advantage of the large stain glass windows to either side of the hall. At first floor level, the floor has been set back from the two large side windows to ensure they remain uninterrupted by forming a void to ensure their continuity. By restoring the lead work and repairing the stain glass where required, these windows, along with the main rear window will provide the home with a rainbow of colour and ensure the history of the building envelope remains alongside a new contemporary interior. The main front door of the property requires replacing.

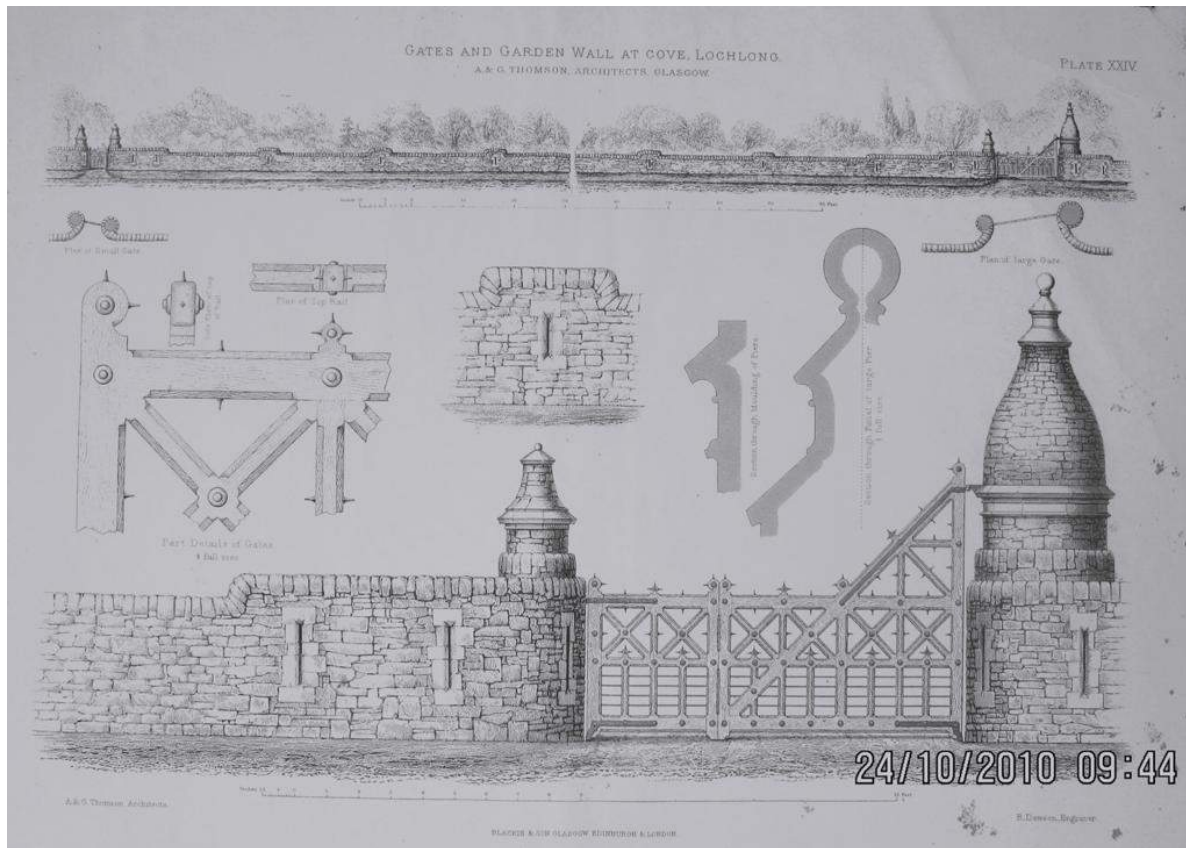
Image of original gate-pier design shown for illustrative purposes. As built walls, gate-piers and gate design vary from the image shown.

The property has two irregular pairs of gate-piers, comprised of vertically laid ashlar masonry with stugged sandstone bands, stone ogival caps with polished ashlar finials. The stone gate piers (pictured below) require masonry repairs which will be done to the same standard as the existing as-built design and materiality to ensure they remain a feature to this listed building. The timber construction gate and cast-iron reinforcements will require repairing or possible replacement – again the same materiality and design will be implemented to stay true to the original character of the property.

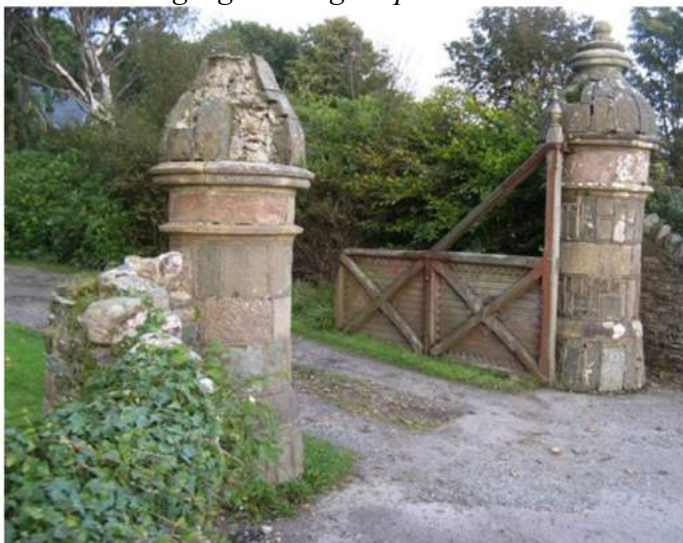
Craigrownie Church Damaged gate piers (10/9/2009)
© Scottish Civic Trust
